RECYCLING AND WASTE DISPOSITION SUBCOMMITTEE

MEETING SUMMARY

WIPP Underground Fire Accident Investigation Summary February 5, 2014

WIPP Underground Radiological Event Investigation Summary February 14, 2014

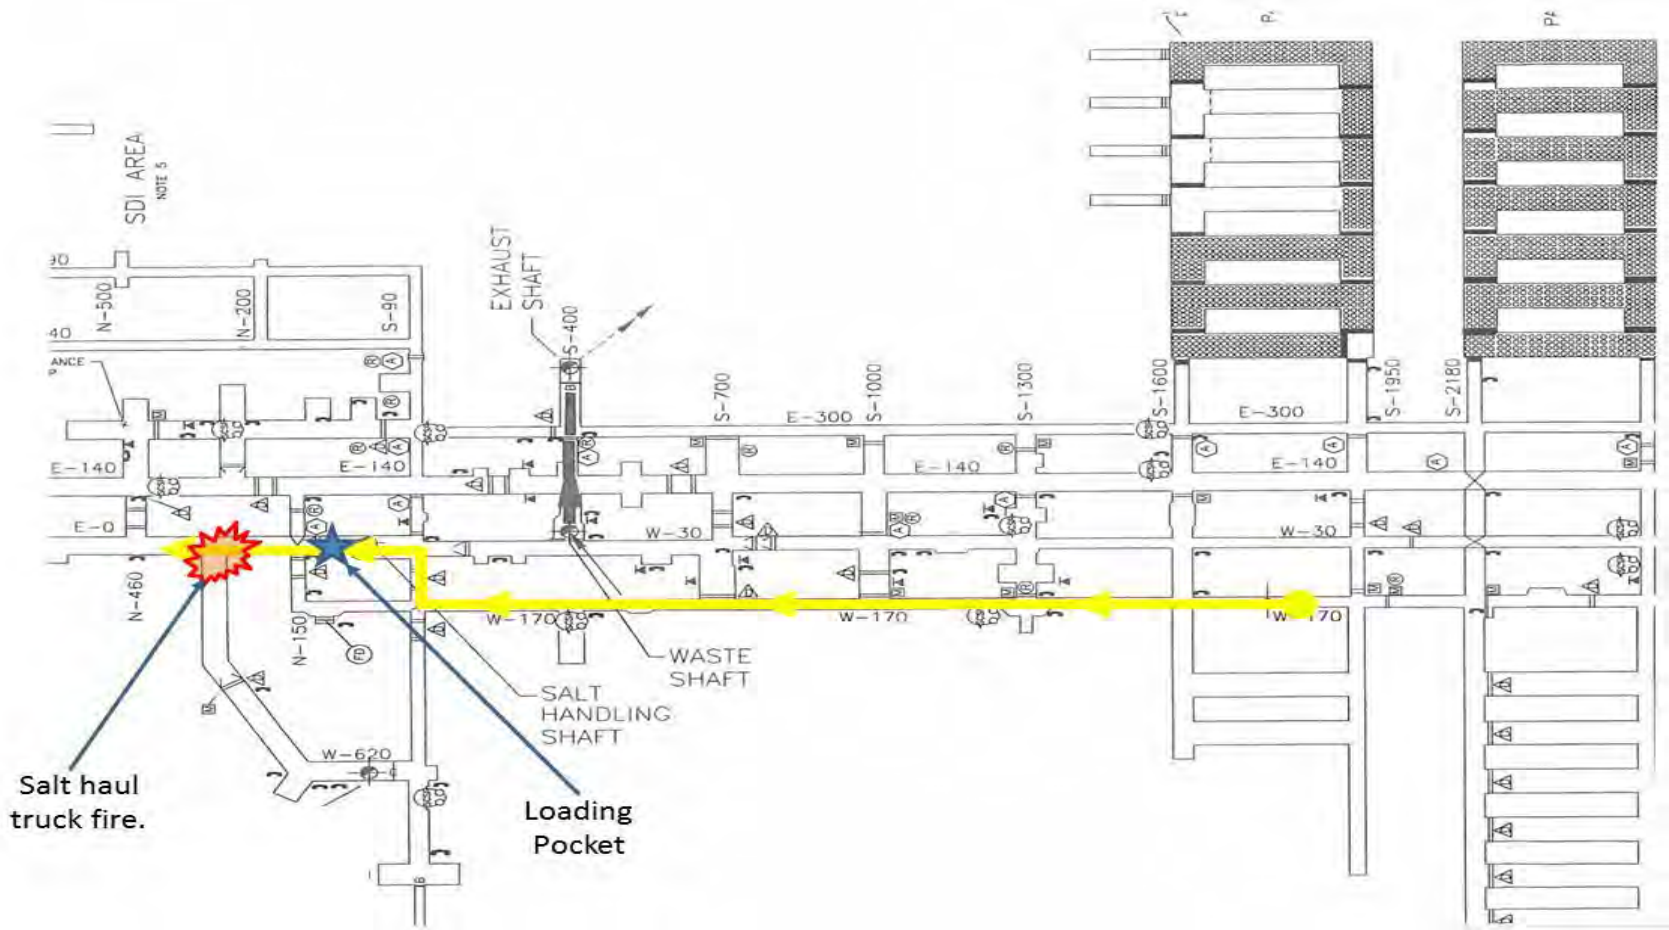
Accident Scene

On February 5, 2014, at approximately 11:00 AM, the Waste Isolation Pilot Plant in Carlsbad, New Mexico suffered an underground fire in a salt hauler vehicle. There were 86 people in the mine at the onset of the fire, all exited the mine safely. Six personnel were transported to the Carlsbad Medical Center for smoke inhalation and an additional seven personnel were treated on-site.

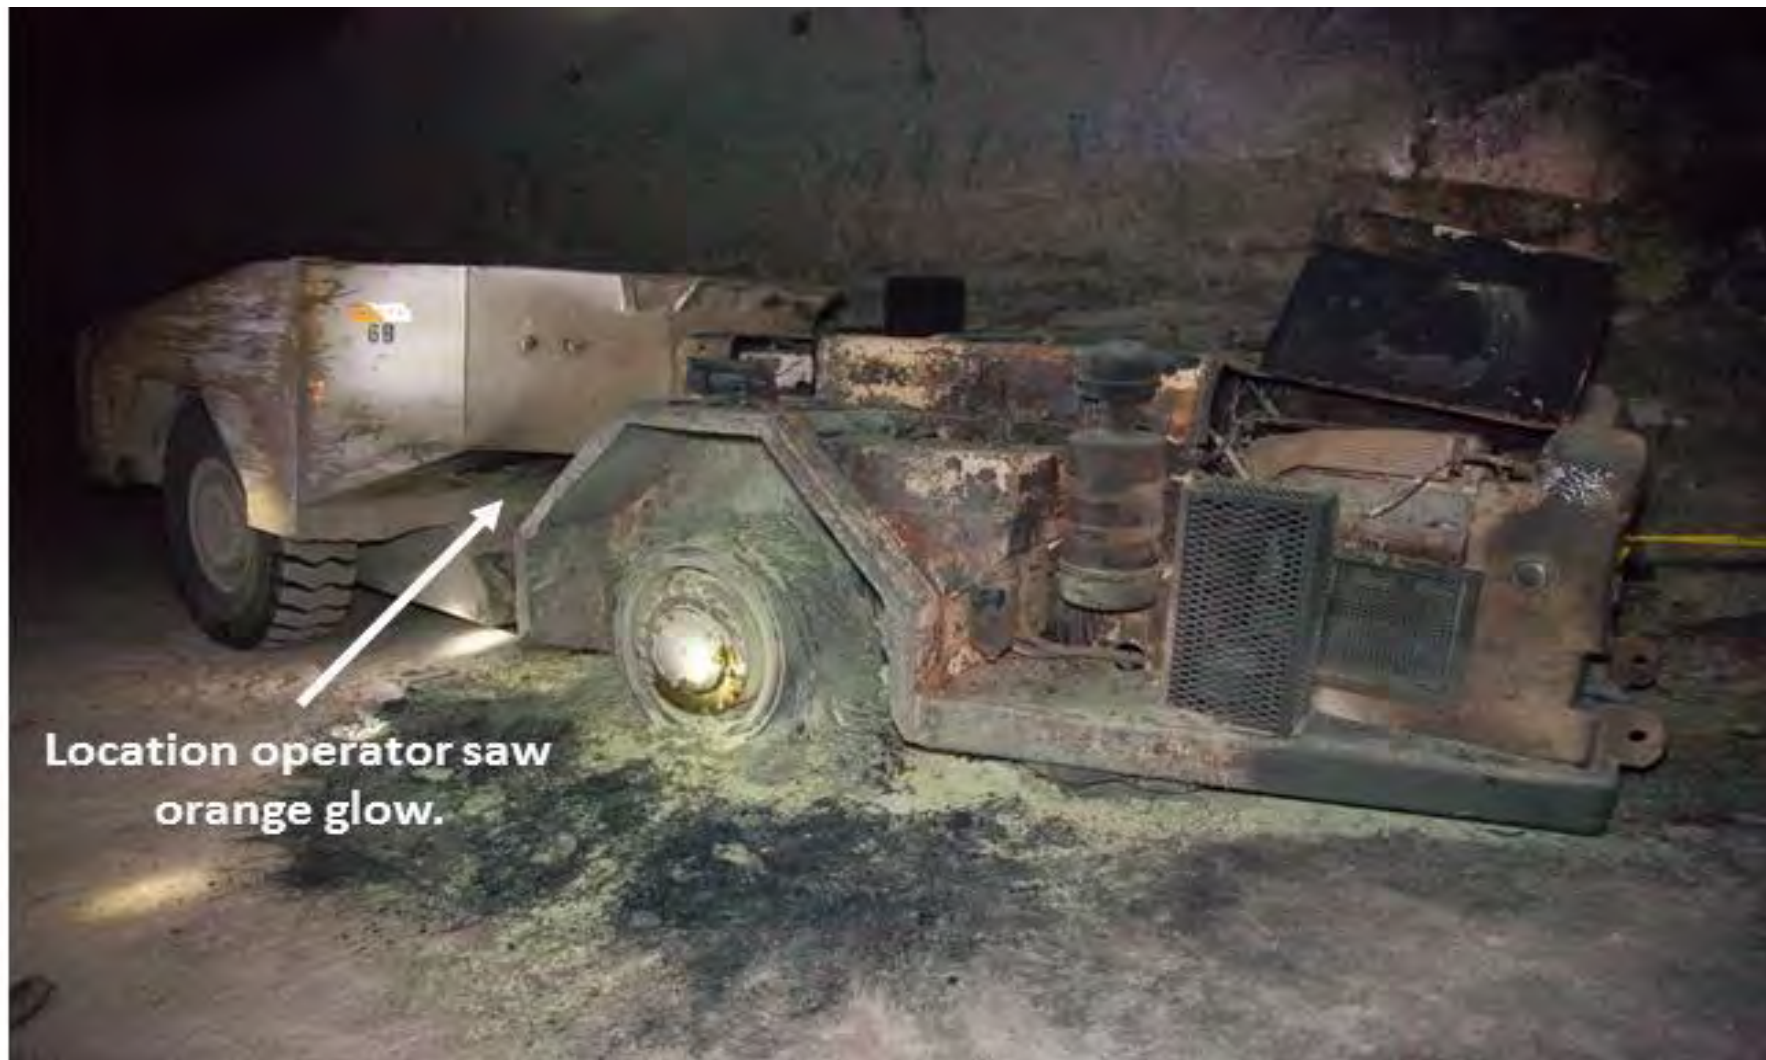
Salt Haul Truck

The EIMCO Model 985, 15 ton haul truck is a diesel powered vehicle used to haul salt from the mine. This is an aged piece of equipment, approximately 29 years old.

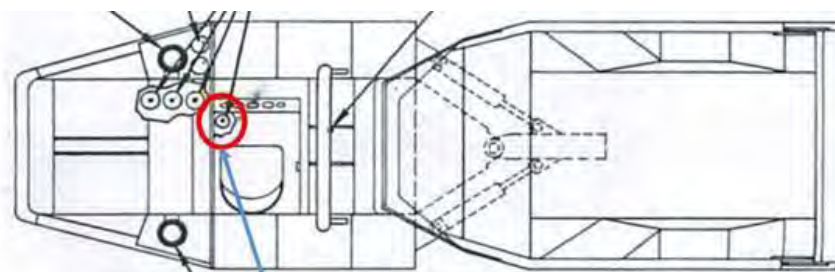
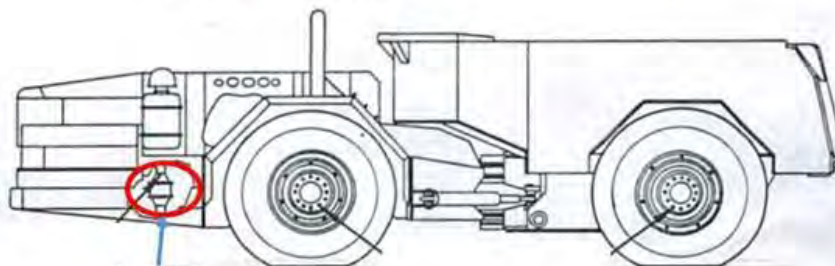
(a) Plan View

Initial location of access panel

(b) Elevation

Suspected
ignition point

(c) Power System Elevation

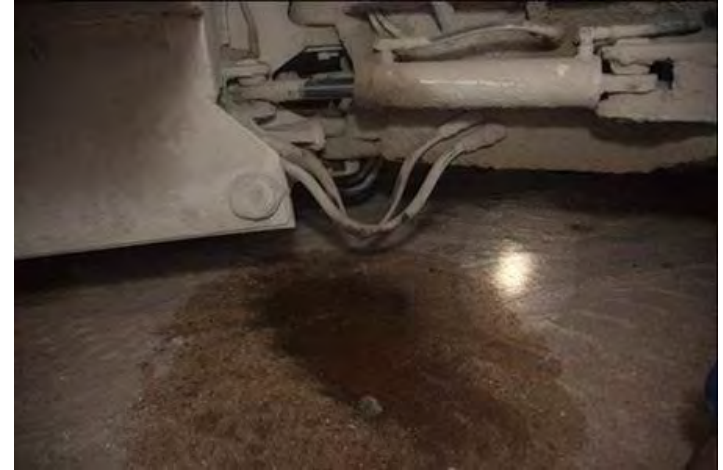
- Maintenance program was ineffective
- Fire protection program was less than adequate
- CMR response (evaluation and protective actions) were less than adequate

Hydraulic Leak under Sister Vehicle

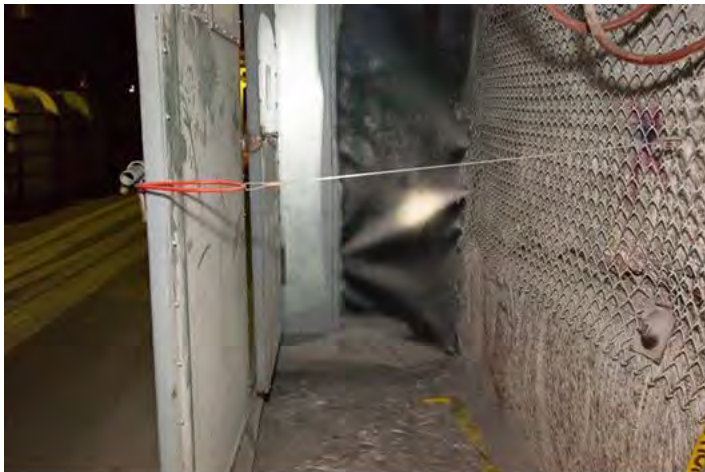
Air Lock Doors Wired Open

- **Operability and recognition of impaired critical safety equipment,** e.g., salt haul truck combustible build up; discontinued use of the vehicle wash station; chaining open of ventilation doors impairing remote operation; inoperable ventilation fans; out-of-service regulator/damper; inoperable mine phones ; emergency lights in the Waste Handling Facility; obscured evacuation reflectors; decision and analysis to disable the automatic fire detection and suppression system, etc. No method to readily understand status and impact of impaired mine safety related equipment.

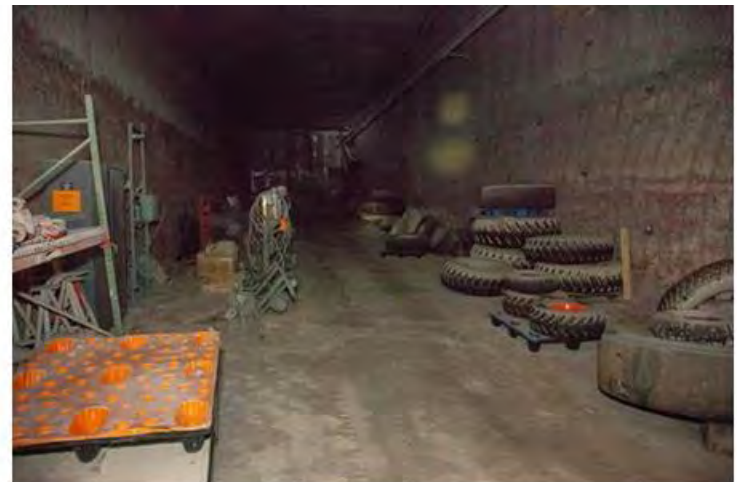
Combustible Loading in the Mine

- **Inadequate combustible loading program in the underground.**
- **Inadequate Fire hazard Analysis** (i.e. analysis of a fire near a shaft)
- **Maintenance, Emergency Management/Preparedness programs and NWP contractor assurance system (CAS) and CBFO oversight** were evaluated as **ineffective.**

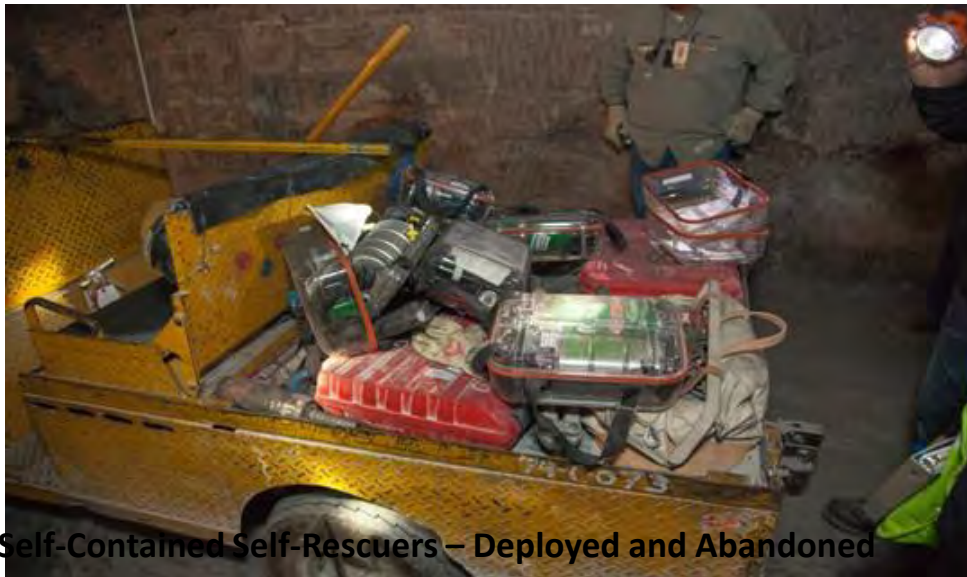
Self-Contained Self-Rescuers – Deployed and Abandoned

- **Ineffective training and drilling**
 - No unannounced drills.
 - No donning of self-rescuers or SCSRs during training or drills, or hands on training with portable fire extinguishers.

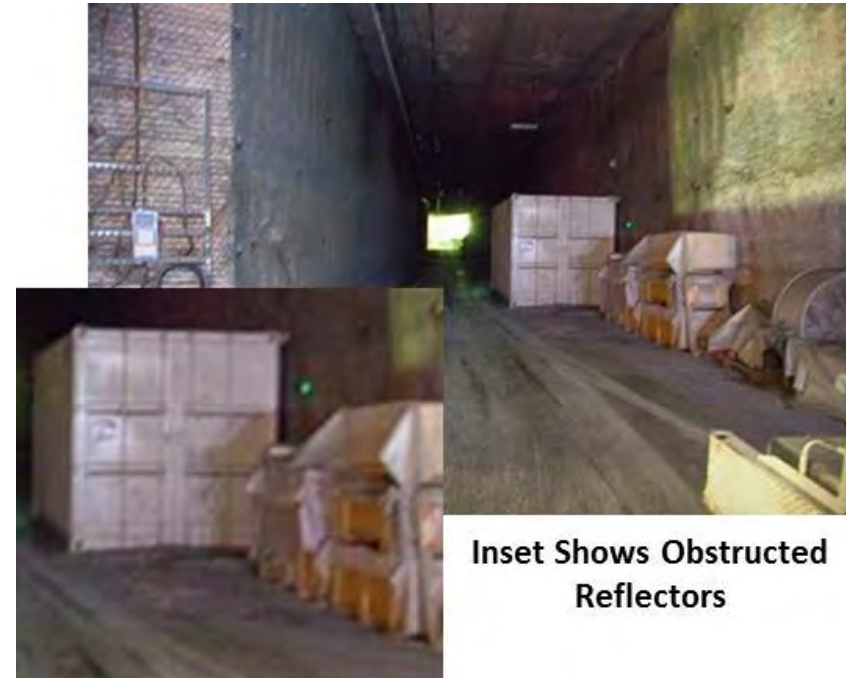
Inset Shows Obstructed Reflectors

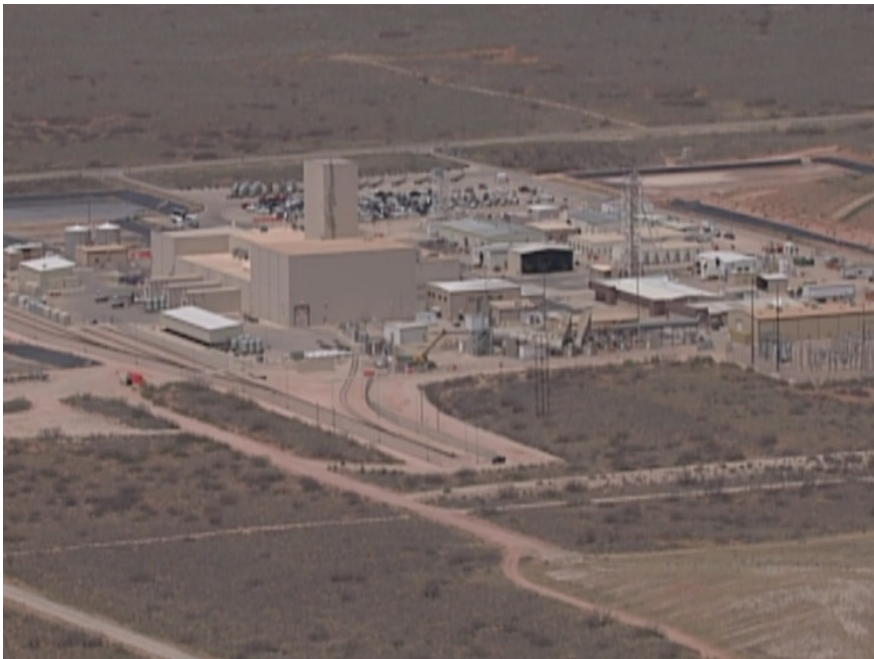
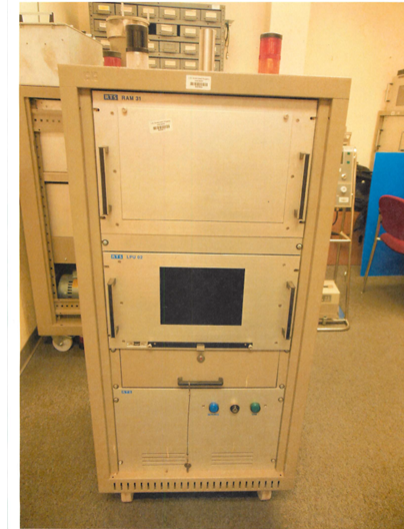
The alarm was from a Continuous Air Monitor (CAM) in the underground that was monitoring an active transuranic (TRU) waste panel.
